OTTA SEAL TRIALS IN KWAZULU-NATAL, SOUTH AFRICA

Abstract

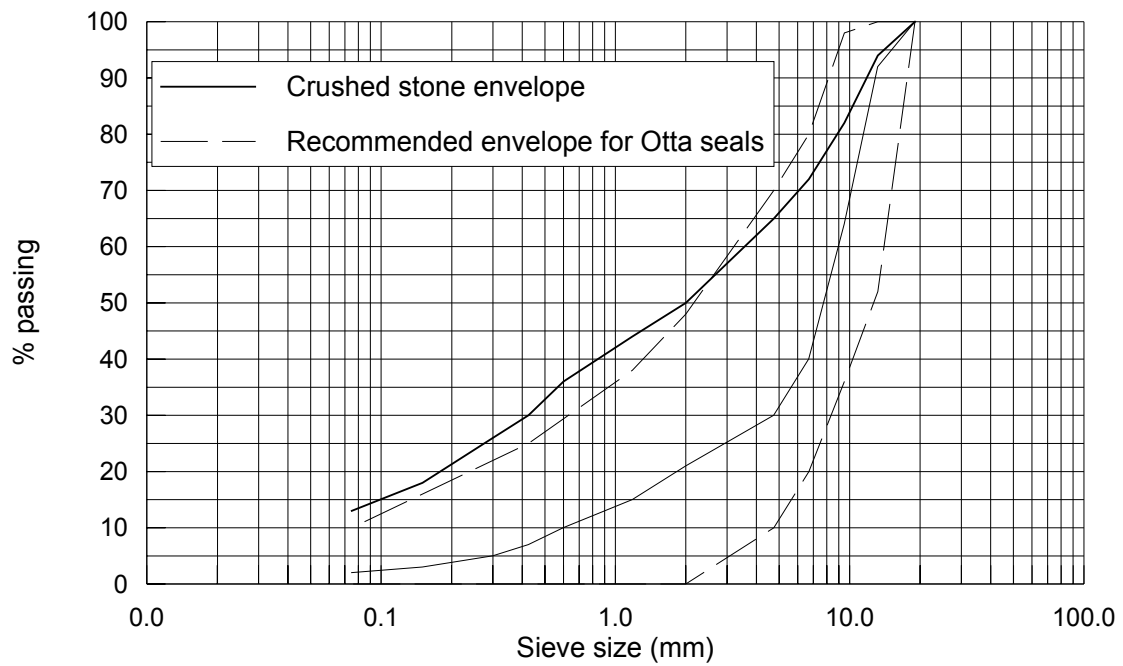
Two types of aggregates were used, a crushed quartzite rock and a decomposed granite. The crushed rock aggregates had good physical properties but, as shown in Figure 3, had grading from marginal to out of specification for Otta seals. The crushed rock was gap graded forming an open texture with a fair proportion of oversized stones on the one end and significant proportions of fines on the other end.

Figure 3: Grading envelope for crushed rock aggregates.

- The performance of both the crushed stone and natural granite aggregates was generally unsatisfactory. This can be attributed in part to grading, which was partly outside the recommended envelope.

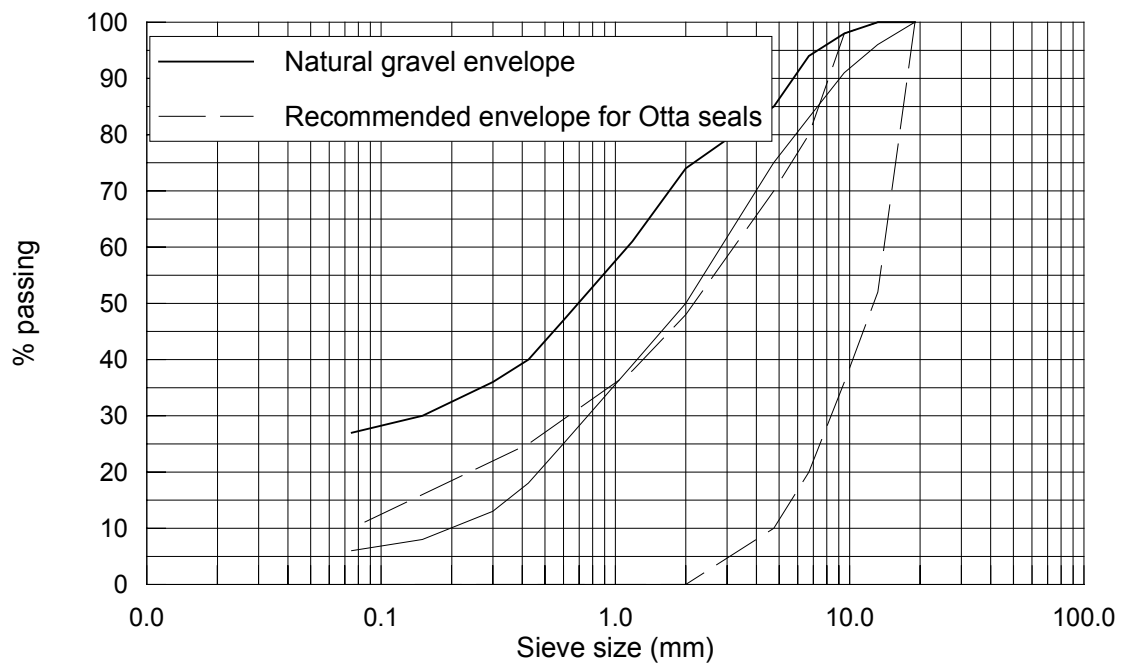
The decomposed granite aggregates had lower crushing strength and grading that was also marginal to out of specification (Figure 4).

Figure 4: Grading envelope for natural gravel.

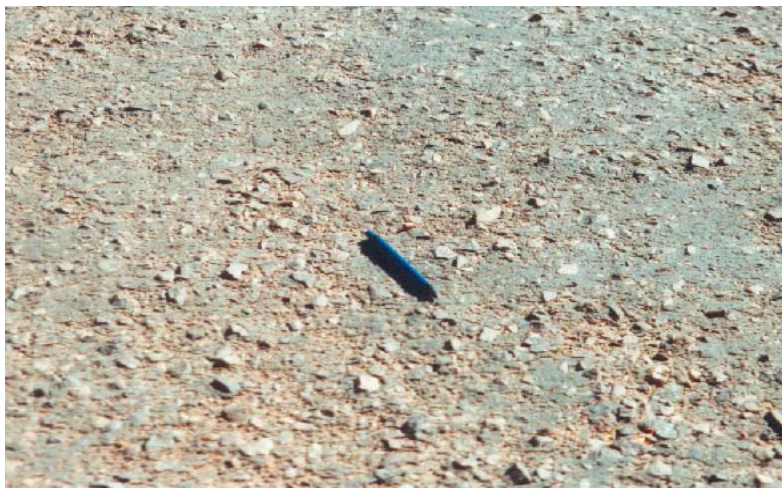
The interaction between aggregate and binder in Otta seals is a gradual process. As a result, one week after construction there was still a large quantity of loose aggregate on the pavement and shoulders (Figure 5). Telltale signs of the kneading affect between the binder and aggregate could be seen along the crown and wheel paths. At this stage the only distinguishing feature separating the various trial sections was the difference in colour and texture of the aggregates used. The gap graded bluish grey crushed rock sections were clearly distinguishable from the denser, yellowish-brown decomposed granite sections.

Figure 5: Appearance of a crushed rock section one week after construction.

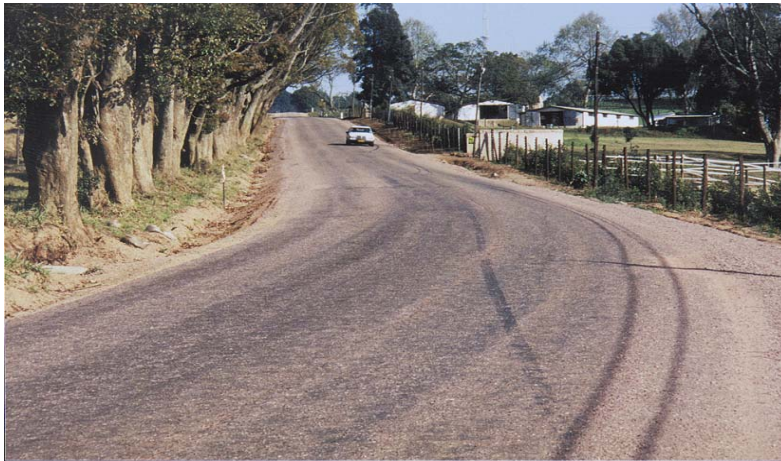
The binder had worked its way completely through the aggregate particle interstices displaying typical Otta seal characteristics (Figure 6). Trial sections consisting of the natural gravel where the higher binder application rate was used exhibited signs of bleeding. This was particularly true of Sections 7 and 8.

Figure 6: Characteristic premix look of Otta seal two months after construction.

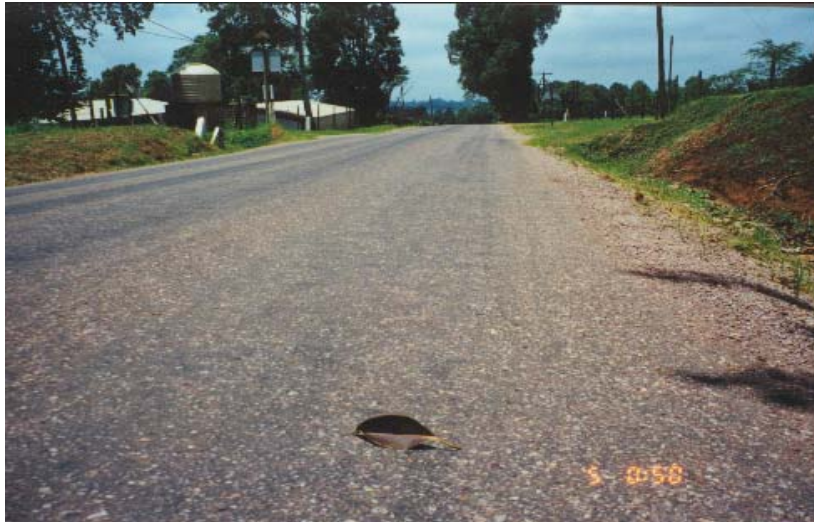
Six months after construction the Otta seal had completely cured in all the test sections. The whole road had a uniform dark premix-like appearance with variable bleeding along the wheel paths (Figure 7). Natural gravel sections tended to bleed more than the crushed stone sections.

Figure 7: Bleeding along the wheel paths after 6 months.

- Binder application rates and amount of cutback appear to influence the performance of the Otta seal as evidenced by the excessive bleeding of the natural granite sections in which the amount of cutback was increased from 8 to 11 percent.
