AFRICAN RENAISSANCE ROADS UPGRADING PROGRAMME (ARRUP)

SAICE BRANCH AWARDS – 2003 COMMUNITY BASED PROJECTS

The Construction of Main Road 68

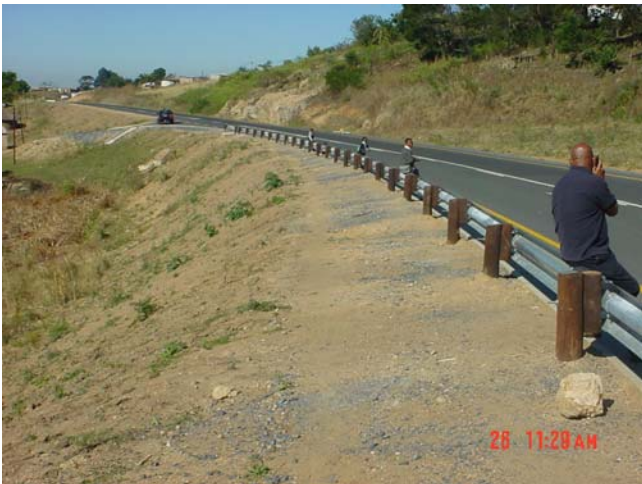
Before

The existing sidewalks before commencement of work. The shoulders were generally too narrow.

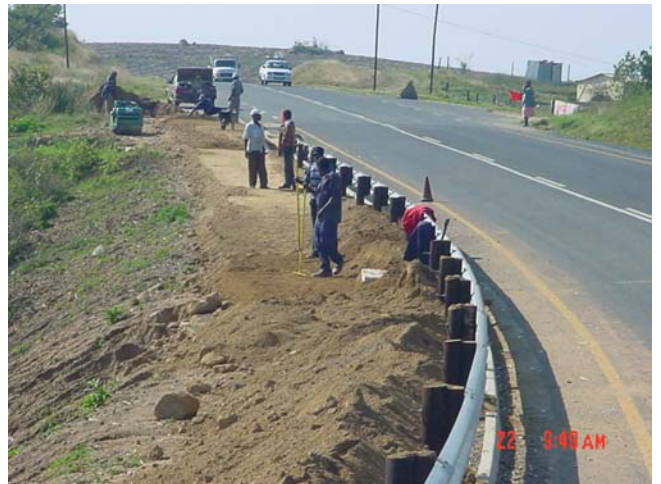
During

Fill widening and gravel base construction.

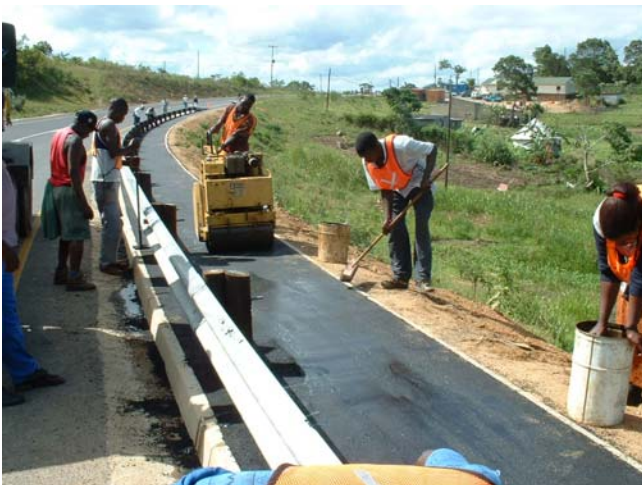
During

The compacted gravel base was primed and then surfaced with a 20mm asphalt layer.

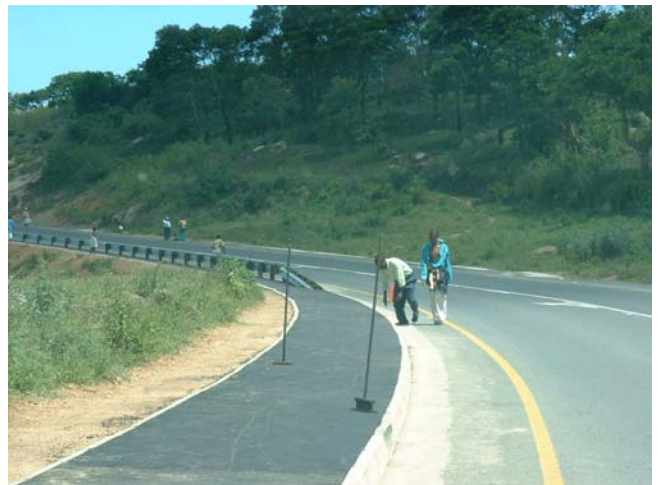
After

The completed asphalted sidewalks.

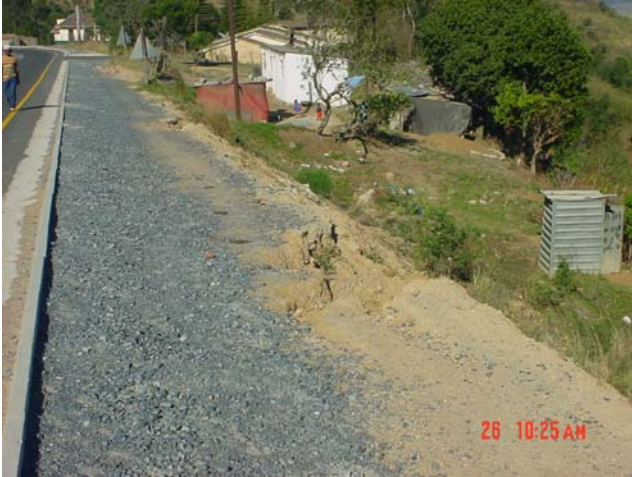
<p data-bbox="627 813 735 837">26 10:25 AM</p> <p data-bbox="145 909 770 943">Existing shoulders with evidence of erosion.</p>

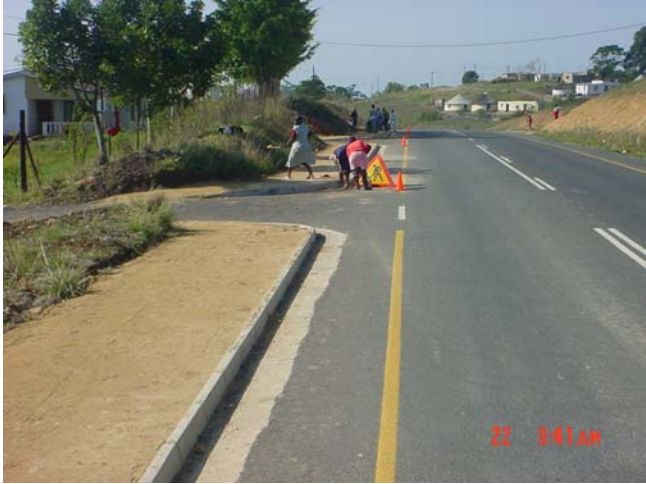
<p data-bbox="1358 813 1473 837">22 9:41 AM</p> <p data-bbox="868 909 1525 987">Traffic accommodation during the construction.</p>

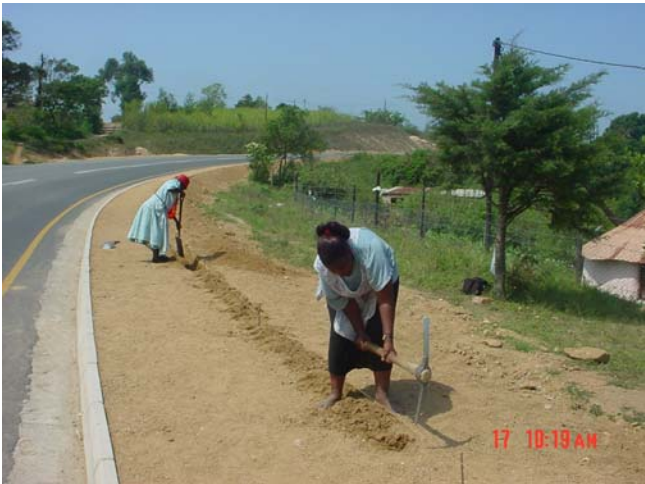
<p data-bbox="639 1664 748 1688">17 10:19 AM</p> <p data-bbox="145 1762 842 1832">Ladies excavating for the mini-kerb at the back of the sidewalk.</p>

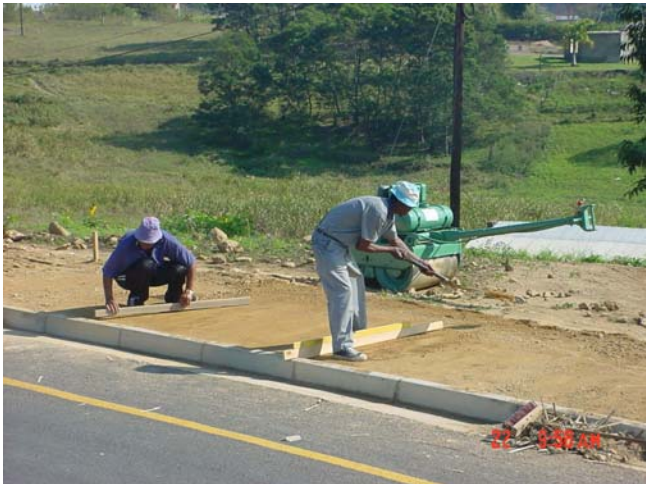
<p data-bbox="1358 1664 1466 1688">22 1:37 PM</p> <p data-bbox="868 1762 1525 1870">Workers were trained to use templates to grade the gravel base to the required 2% fall towards the road edge.</p>

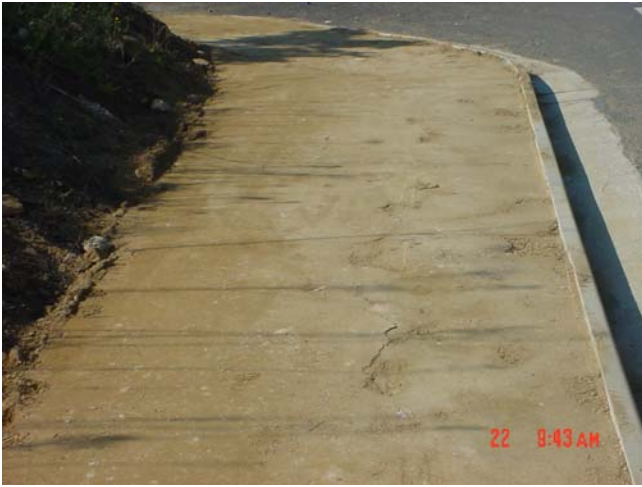
During

Compacted gravel base ready for priming.

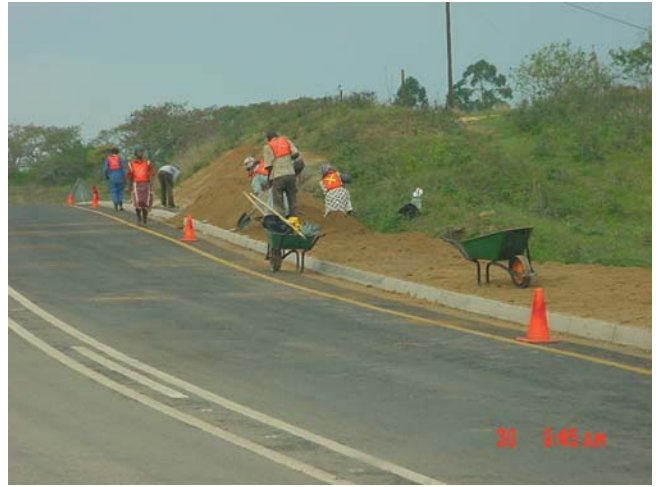
During

Workers spreading gravel material to be compacted by the pedestrian roller.

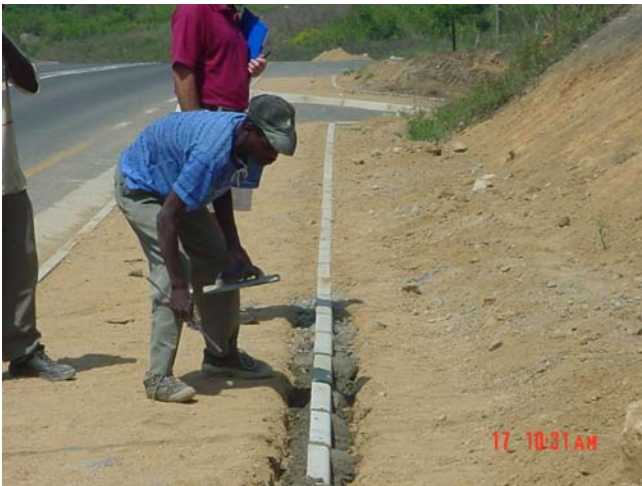
During

A newly trained kerb-layer constructs haunching to the mini-kerb. The neatness and accuracy in the line and level is remarkable.

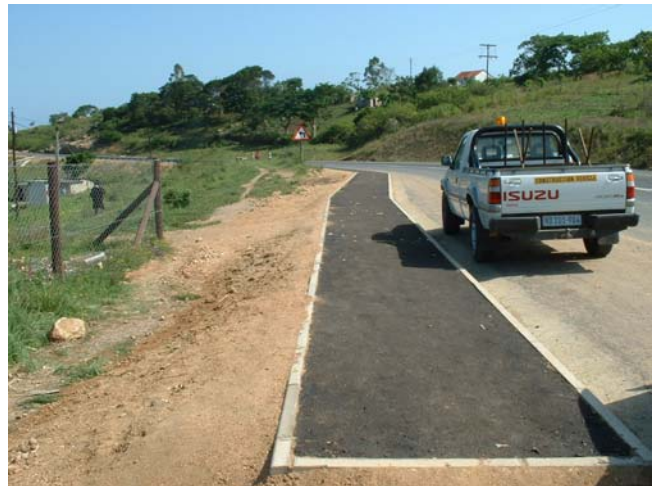
After

A completed section of the asphalted sidewalks.

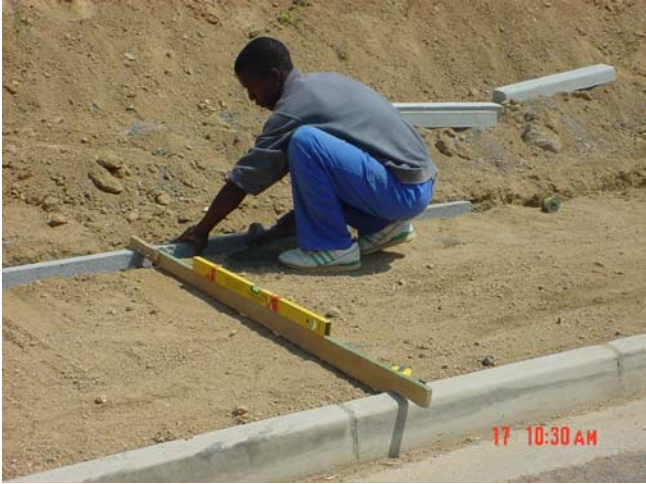
<p data-bbox="145 880 842 954">A kerb-layer levelling the mini-kerb with the existing figure 6 kerb.</p>

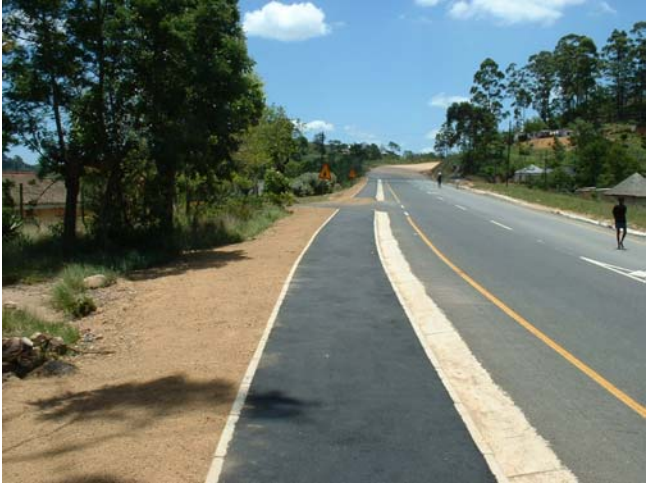
<p data-bbox="869 880 1528 987">Neatening-off of the banks at the back of the sidewalks was done well and created a well-finished product.</p>

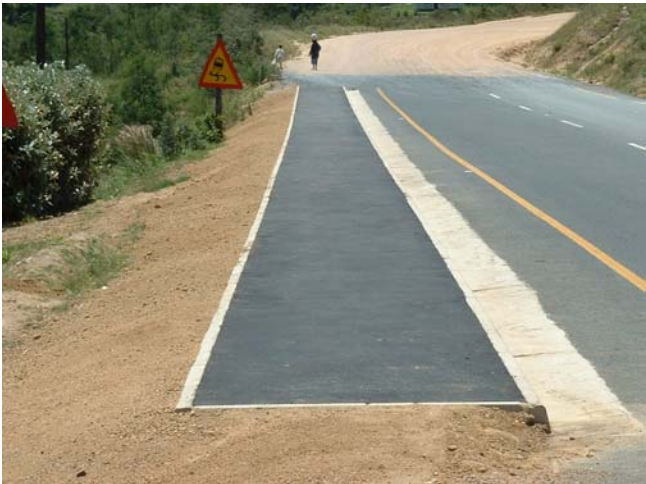
<p data-bbox="145 1760 823 1796">More completed sidewalks with trimmed banks.</p>

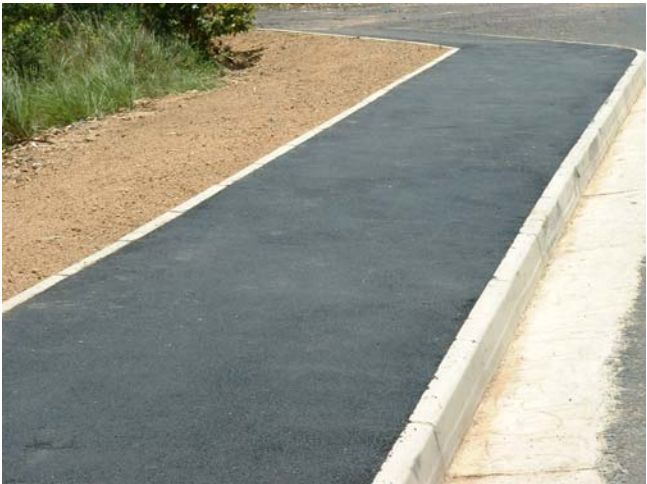
<p data-bbox="869 1760 1182 1796">Completed sidewalks.</p>

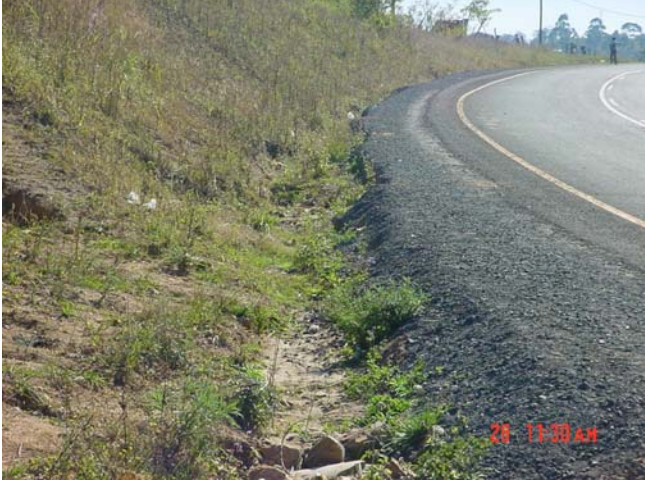
<p data-bbox="145 920 842 992">The existing open side drains had been severely eroded in places.</p>

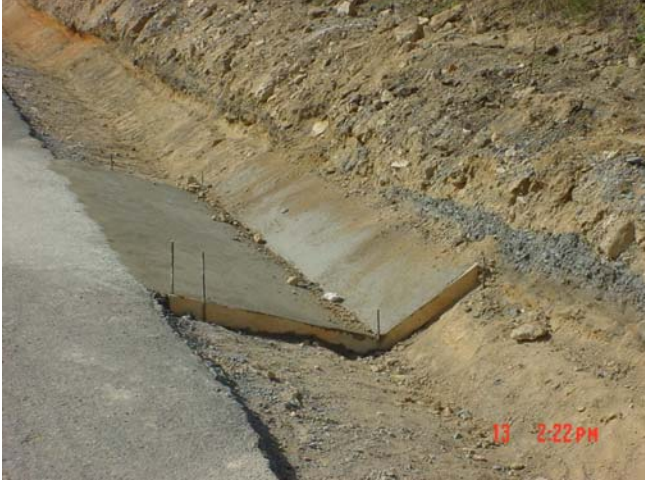
<p data-bbox="869 920 1528 1061">Existing drains were hand-trimmed and compacted. Formwork was erected and the panels were poured with concrete mixed on site.</p>

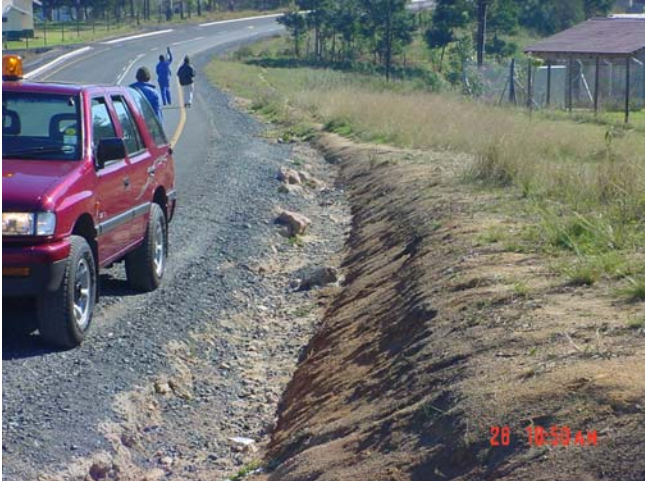
<p data-bbox="145 1845 512 1881">Existing v-drain condition.</p>

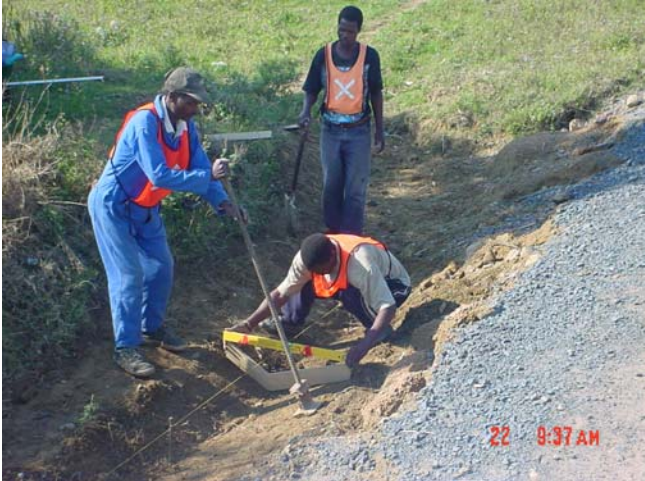
<p data-bbox="869 1845 1528 1955">Semi-skilled workers use templates to obtain the correct v-drain shape. A line level was used to create a fall to an outlet point.</p>

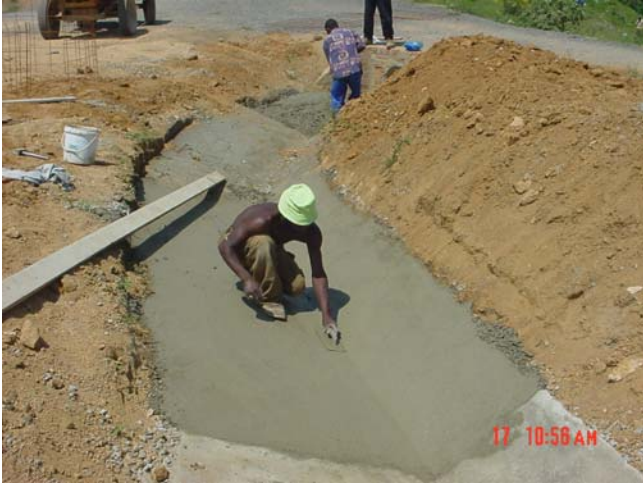
<p data-bbox="145 913 791 1057">A concrete chute outlet being floated.</p>

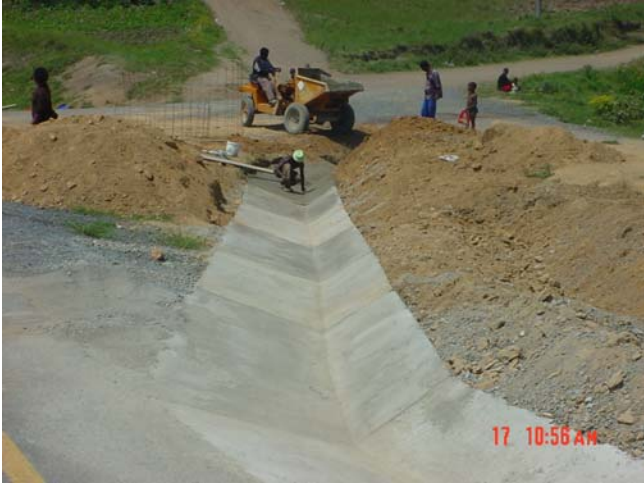
<p data-bbox="869 913 1516 1057">The concrete chute almost complete. The laying of panels in alternate sections can be clearly seen.</p>

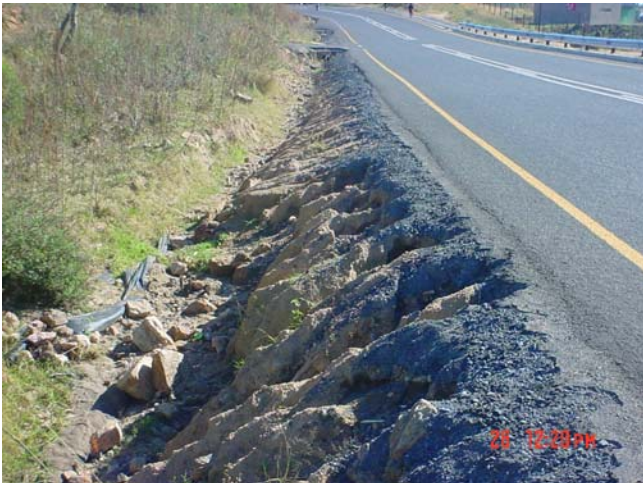
<p data-bbox="145 1798 791 1977">The extent of the eroded road banks and drains involved a large amount of corrective work to be carried out before trimming and construction of the drains could be undertaken.</p>

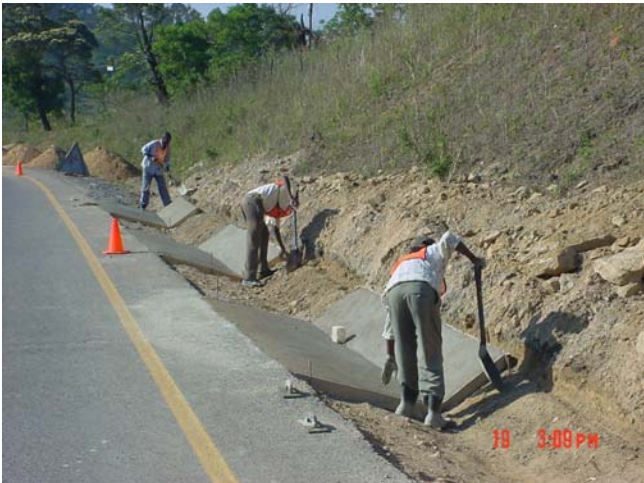
<p data-bbox="869 1798 1516 1977">Concrete v-drain slabs laid in alternate panels.</p>

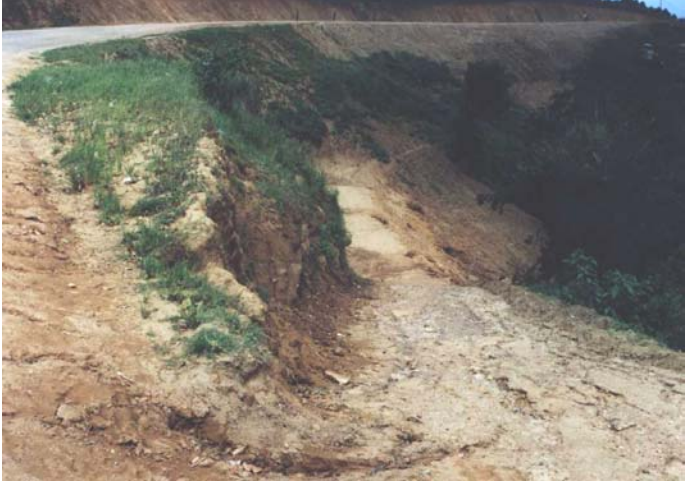
<p data-bbox="145 920 639 958">Partially built fills in poor condition.</p>

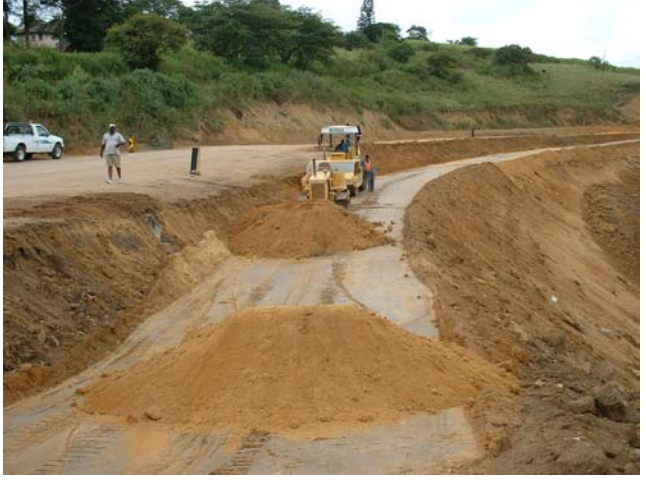
<p data-bbox="868 920 1342 958">Benching and building of the fills.</p>

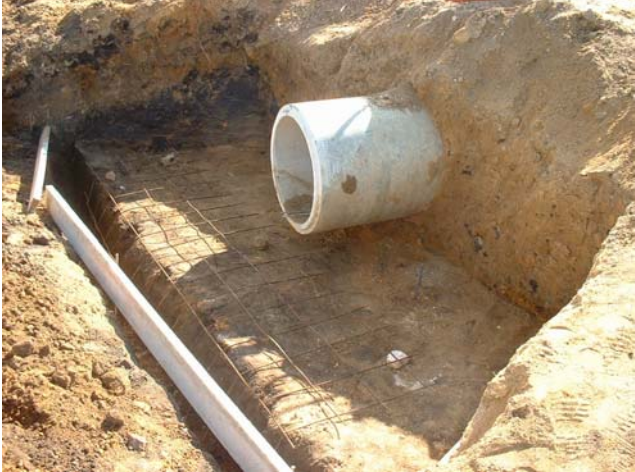
<p data-bbox="145 913 842 987">An outlet apron slab being prepared for concreting.</p>

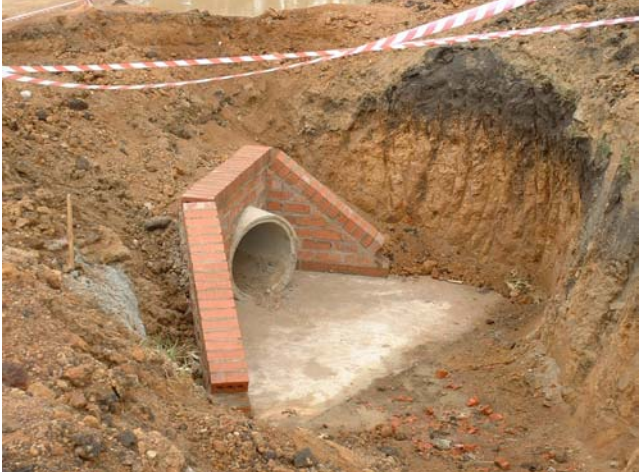
<p data-bbox="869 913 1474 949">A completed headwall, to be neaten off.</p>

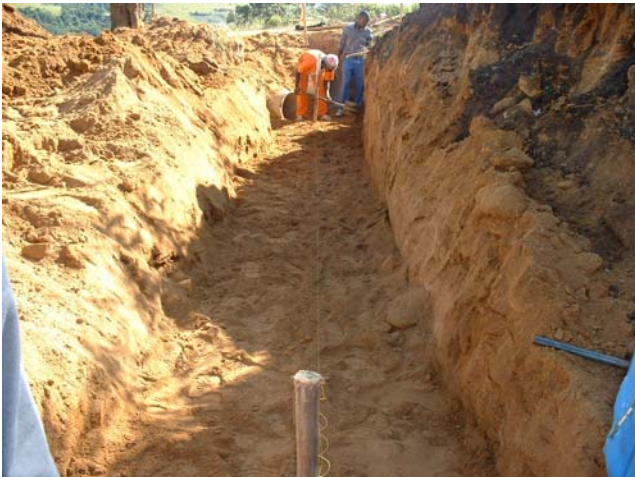
<p data-bbox="145 1780 799 1816">Pipe bedding being prepared to line and level.</p>

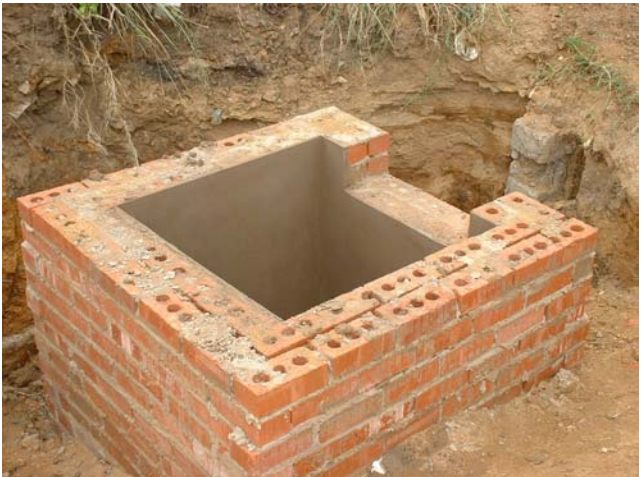
<p data-bbox="869 1780 1358 1816">Building of a manhole in progress.</p>

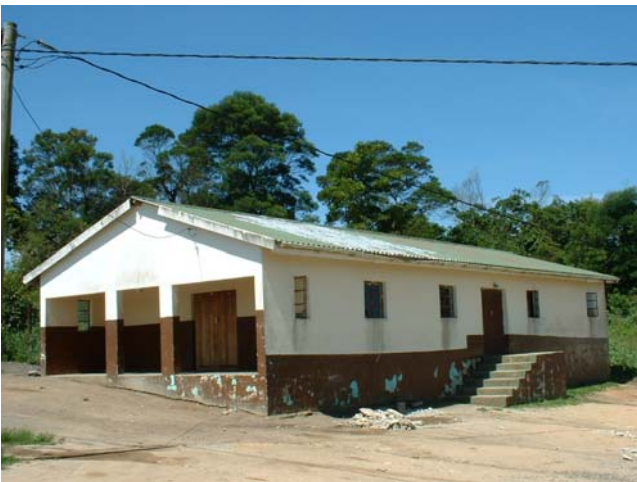
Before

The Oshabeni Training Centre Hall at the site camp, seen here, was in need of some repair and restoration.

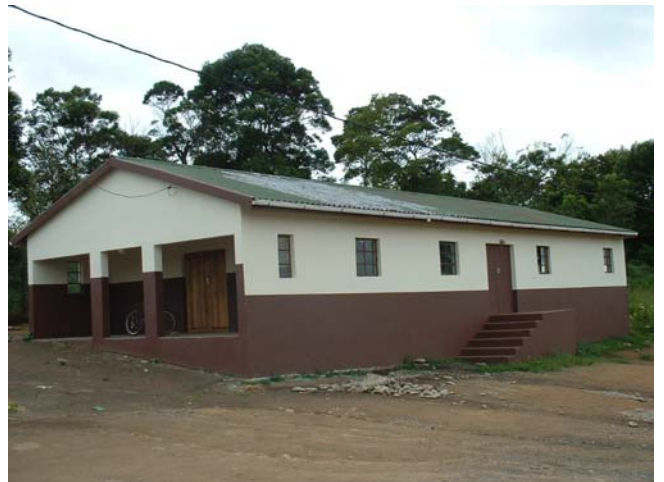
After

The broken fascia boards and drains were fixed and walls were sanded down and re-painted.
