***Report to DE Consultants on a Geotechnical Investigation
carried out for the Proposed Lovu Pedestrian Bridge 3383,
KwaZulu-Natal***

Reference : 15-015R01

Dated : November 2015

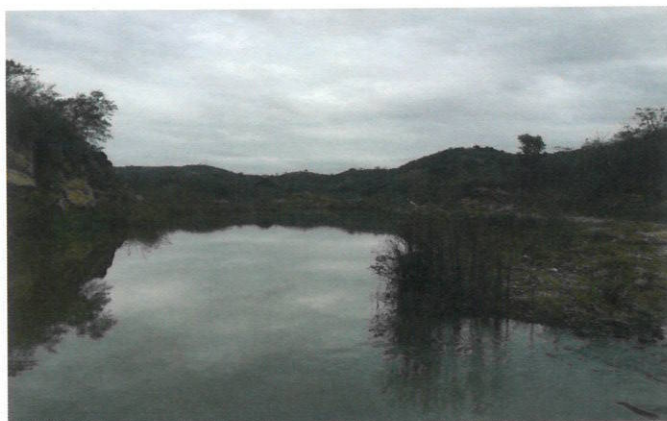
Plate 1: Approximate location of bridge crossing showing the rocky bank on the southwest and the sandy bank on the northeast

The final alignment for the pedestrian bridge was selected on the basis of the characteristics of the local geology; the south-eastern abutment is situated on weathered tillite rock, while the north-western abutment is situated some 10m from an undercut river bank. This location was also considered suitable on the basis of hydrology, the rock bank on the south being on the undercut (or high velocity) side of the river provides a natural hedge against erosion while the northern abutment is on the point bar side of the river with the river in deposition mode in this area and thus lower velocity.

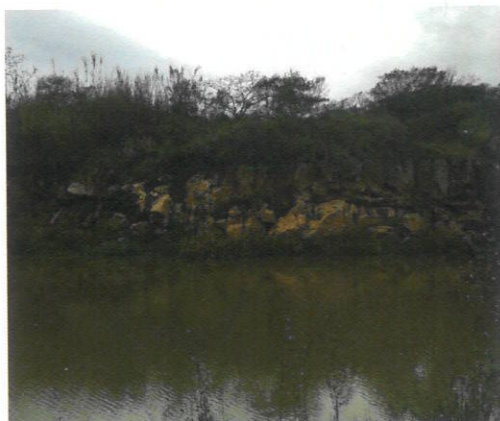
Plate 2: Tillite bedrock beneath the southwest bank

The southern abutment can be founded on the tillite rock which is relatively fresh and sound. It is generally widely to medium jointed, with conjugate jointing sets. The rock is at least hard rock strength.

A maximum allowable bearing of 500 kPa may adopted for the foundations. It will be important to ensure that the footing is not located within 2m of the edge of the rock bank in case there is a long term stability problem with the rock. If it is necessary to have the footing closer than this then rock bolting may be required to secure the long term integrity of the rock founding layer. Once the position of the footing is finalised this aspect can be more carefully evaluated by MSJ.

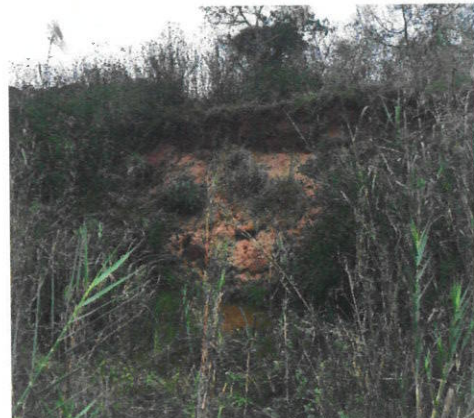
Plate 3: Sandy alluvial soils beneath northeast bank

The northern abutment of the bridge is located over deep, unconsolidated alluvial soils comprising for the most part gravelly silty fine medium and coarse SAND. The alluvium is generally loose becoming medium dense in consistency with depth, with SPT N values in the range and 13 to 18, with some refusals on occasional small to medium sized cobbles of up to about 50 to 100mm diameter. The amount of gravel and cobbles appear to increase significantly below about 10 metres depth to the end of the borehole which is 20 metres.

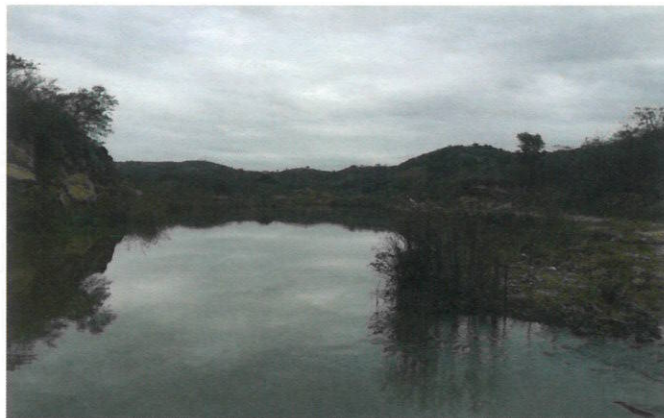
Plate 1: Approximate location of bridge crossing showing the rocky bank on the southwest and the sandy bank on the northeast

The final alignment for the pedestrian bridge was selected on the basis of the characteristics of the local geology; the south-eastern abutment is situated on weathered tillite rock, while the north-western abutment is situated some 10m from an undercut river bank. This location was also considered suitable on the basis of hydrology, the rock bank on the south being on the undercut (or high velocity) side of the river provides a natural hedge against erosion while the northern abutment is on the point bar side of the river with the river in deposition mode in this area and thus lower velocity.

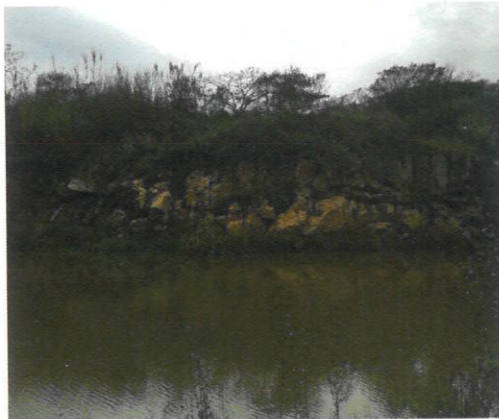
Plate 2: Tillite bedrock beneath the southwest bank

The southern abutment can be founded on the tillite rock which is relatively fresh and sound. It is generally widely to medium jointed, with conjugate jointing sets. The rock is at least hard rock strength.

A maximum allowable bearing of 500 kPa may adopted for the foundations. It will be important to ensure that the footing is not located within 2m of the edge of the rock bank in case there is a long term stability problem with the rock. If it is necessary to have the footing closer than this then rock bolting may be required to secure the long term integrity of the rock founding layer. Once the position of the footing is finalised this aspect can be more carefully evaluated by MSJ.

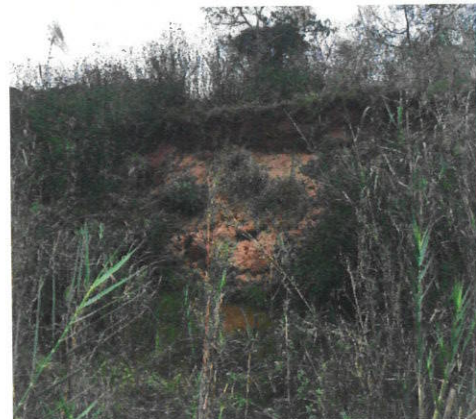
Plate 3: Sandy alluvial soils beneath northeast bank

The northern abutment of the bridge is located over deep, unconsolidated alluvial soils comprising for the most part gravelly silty fine medium and coarse SAND. The alluvium is generally loose becoming medium dense in consistency with depth, with SPT N values in the range and 13 to 18, with some refusals on occasional small to medium sized cobbles of up to about 50 to 100mm diameter. The amount of gravel and cobbles appear to increase significantly below about 10 metres depth to the end of the borehole which is 20 metres.

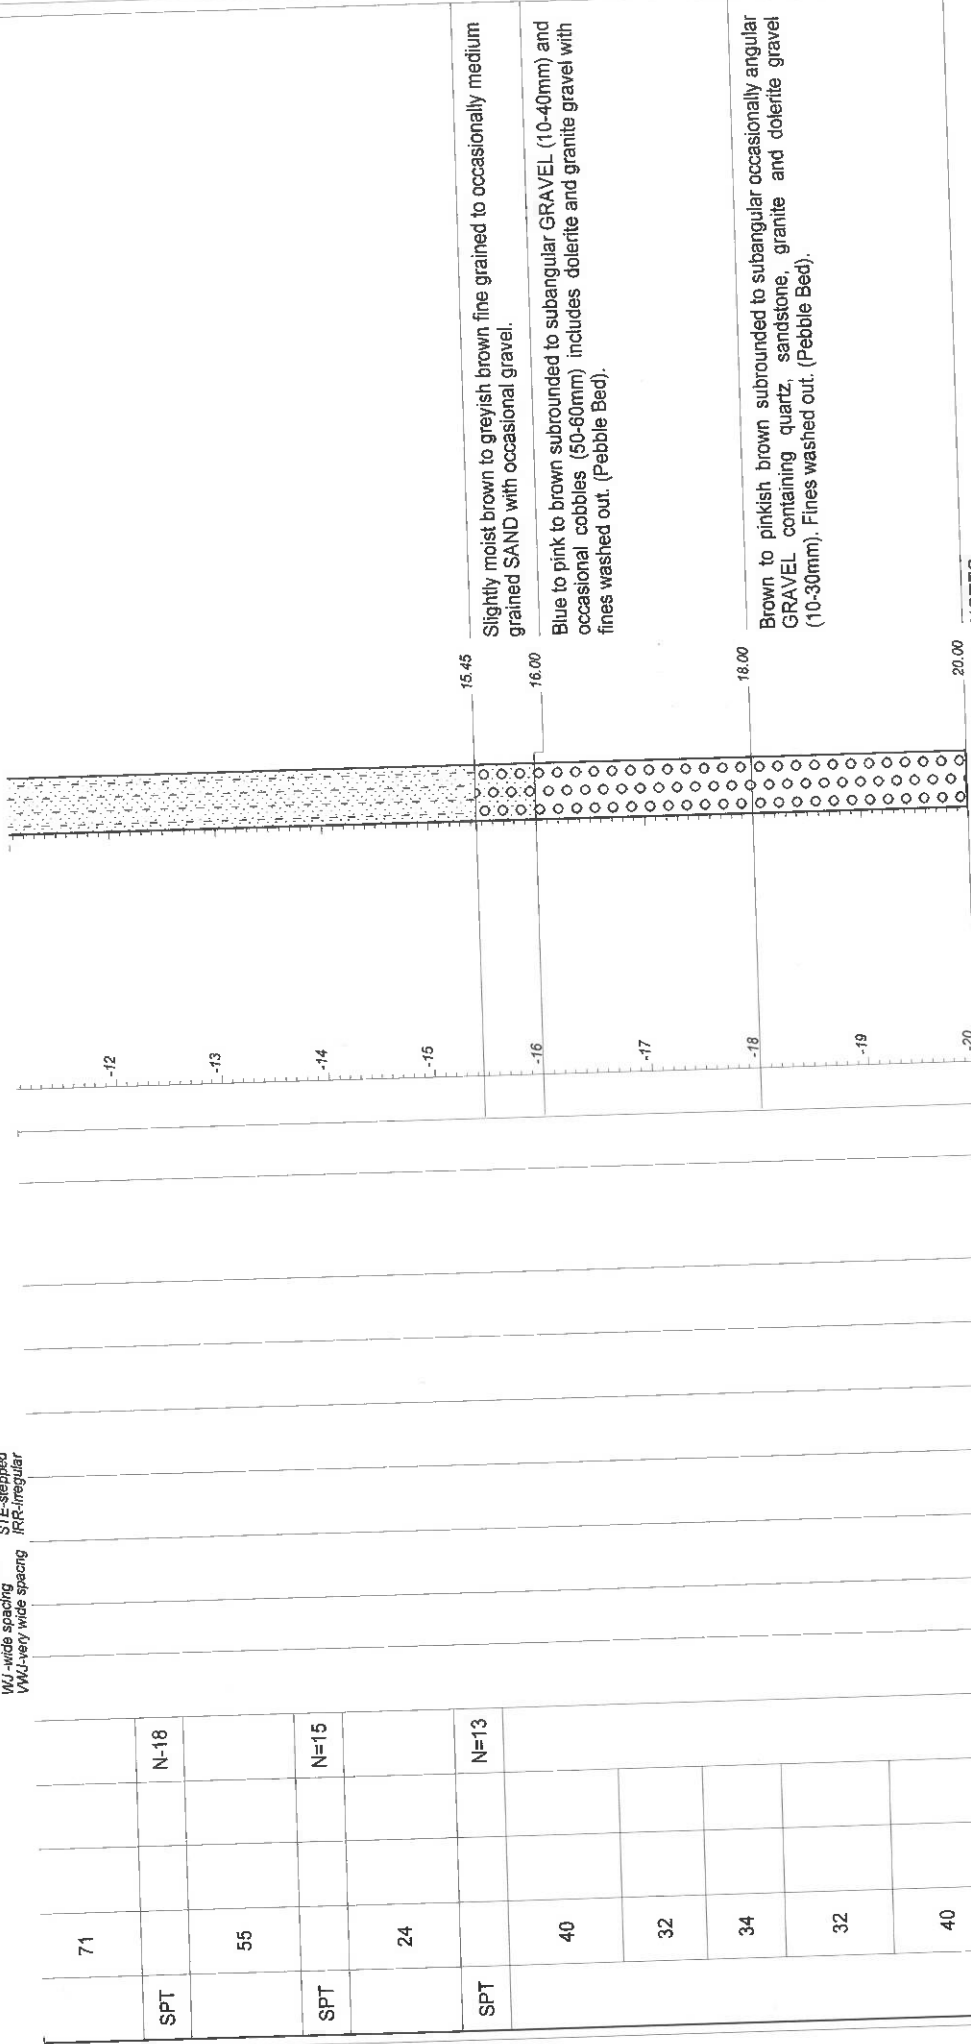
ELEVATION :
X-COORD :
Y-COORD :
HOLE No: BH1
llbvu

Slightly moist brown to greyish brown fine grained to occasionally medium grained SAND with occasional gravel.

Blue to pink to brown subrounded to subangular GRAVEL (10-40mm) and occasional cobbles (50-60mm) includes dolerite and granite gravel with fines washed out. (Pebble Bed).

Brown to pinkish brown subrounded to subangular occasionally angular GRAVEL containing quartz, sandstone, granite and dolerite gravel (10-30mm). Fines washed out. (Pebble Bed).

NOTES
1) End of borehole 20.00m.

Drilling Method	Material Recovery (%)	Core Recovery (%)	RQD (%)	SPT-N	PL/(IS50)	LCS (MPa)	FRAC. FREQ.	JOINT NO OF SETS	JOINT INCLIN (deg)	JOINT SPACING	JOINT SHAPE	JOINT ROUGHNESS	JOINT FILLING & THICKNESS	WEATH. EROSION LEVEL
SPT	71			N=18										
SPT	55			N=15										
SPT	24			N=13										
	40													
	32													
	34													
	32													
	40

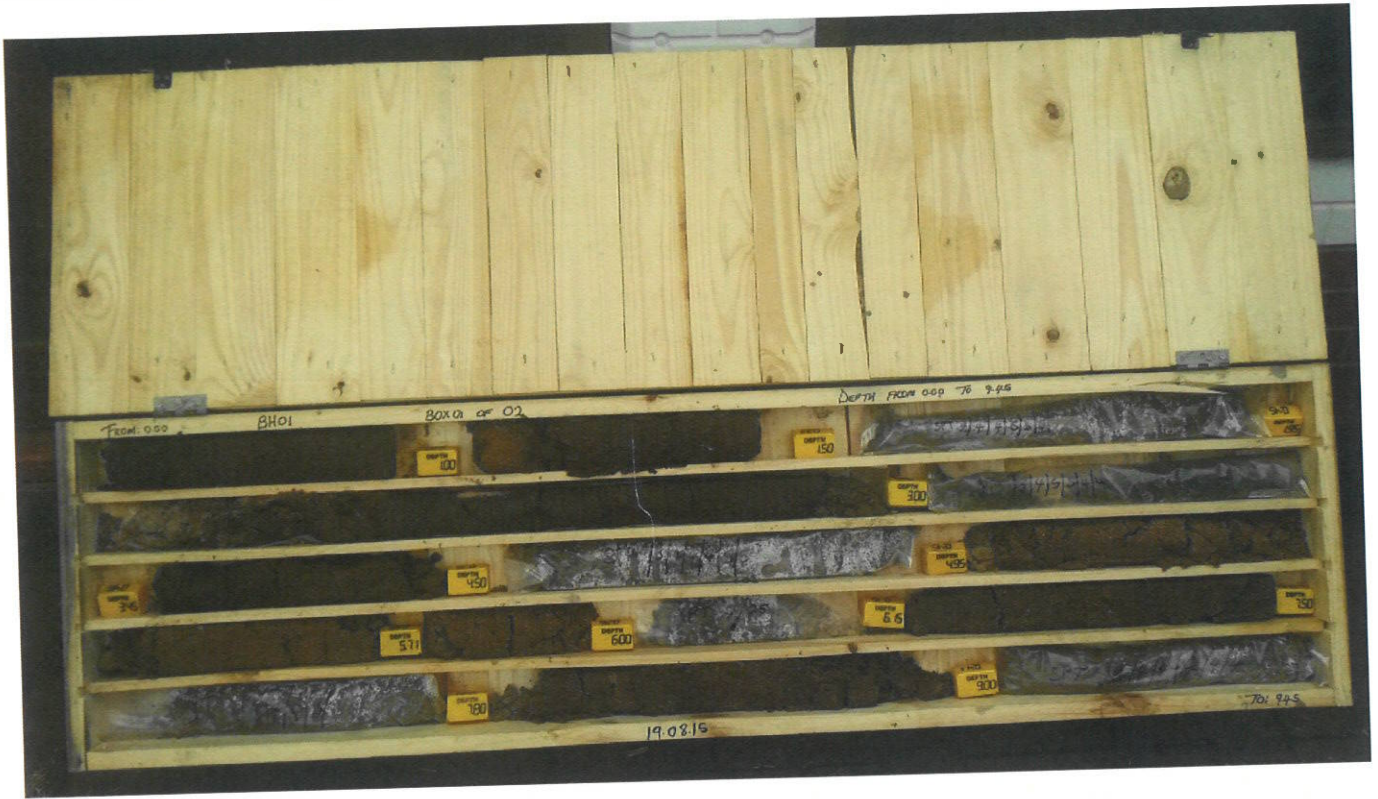
Borehole No. BH1

Depth : 0.00 to 9.45m

Box 1 of 2

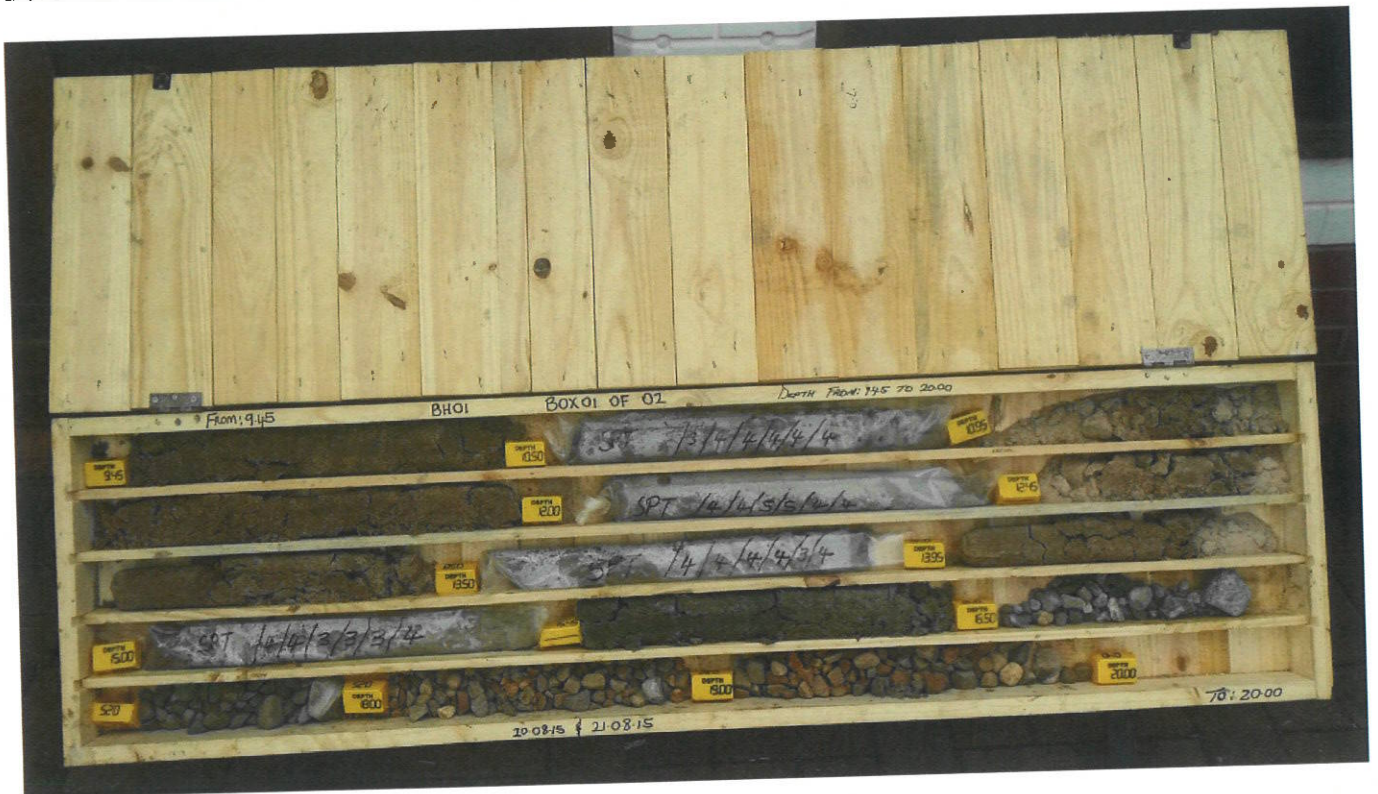
Borehole No. BH1

Depth : 9.45 to 20.00m

Box 2 of 2
